Subchondroplasty: What the Radiologist Needs to Know

OBJECTIVE. Subchondroplasty is a novel minimally invasive procedure that is used to treat painful bone marrow lesions in patients with knee osteoarthritis or insufficiency fractures. The objective of this article is to describe the surgical technique and the pre- and postoperative imaging findings of a small case series acquired at a single center.

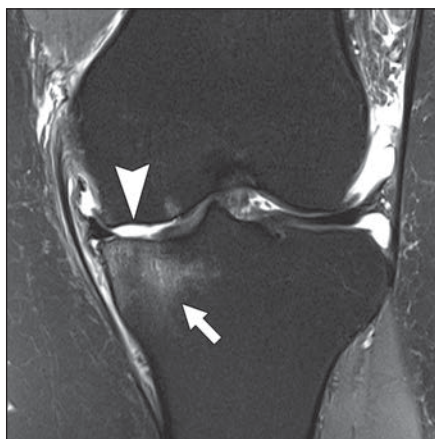
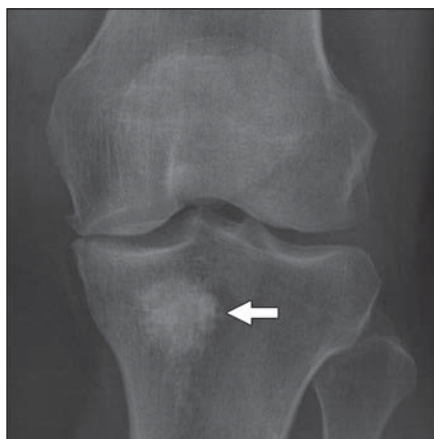
Fig. 1—38-year-old woman with left-sided medial knee pain and swelling. **A**, Preoperative coronal intermediate-weighted fat-saturated MR image (TR/TE, 4100/48) shows focal bone marrow edema in medial tibia plateau (*arrow*) and extensive cartilage loss in medial compartment (*arrowhead*). **B**, Postoperative radiograph obtained after subchondroplasty shows focal opacification (*arrow*) in medial aspect of tibial metaphysis that corresponds to injected calcium phosphate during subchondroplasty. Note that location of injected calcium phosphate in **B** only partially matches location of bone marrow edema in **A**.

Bone marrow edema is well depicted on fluid-sensitive MRI, such as STIR, fat-saturated intermediate-weighted, and fat-saturated T2-weighted sequences [13]. Lesions appear as hyperintense regions within the trabecular subchondral bone often at the site of increased mechanical stress [14, 15] (Fig. 1). The presence of an associated horizontal hypointense linear focus suggests an associated insufficiency fracture (Figs. 2 and 3).

Postoperative radiographs should be compared with preoperative radiographs to identify deposits of the injected calcium phosphate. As one would expect, conventional radiographs show increased density in the bone at the location of the injected calcium phosphate (Fig. 1). The area of the injected calcium phosphate on radiography should

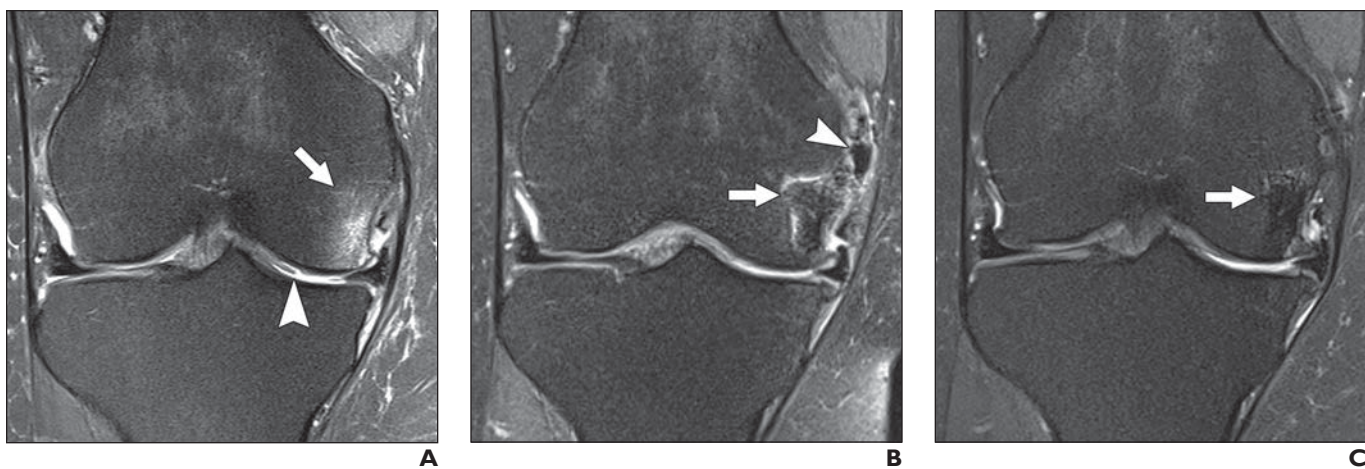
Fig. 5—59-year-old woman with right knee pain after falling 9 months earlier (same patient as in Fig. 4). Temporal evolution of MRI appearance after subchondroplasty is shown.

A, Preoperative coronal intermediate-weighted fat-saturated MR image (TR/TE, 2700/34) shows focal bone marrow edema in medial femoral condyle (*arrow*) and extensive cartilage loss in medial compartment with cartilage delamination in central aspect of medial femoral condyle (*arrowhead*).

B, MR image (TR/TE, 3000/33) obtained 6 months after subchondroplasty shows that injected calcium phosphate is seen as hypointense focal area surrounded by slim hyperintense rim (*arrow*). Note calcium phosphate deposit (*arrowhead*) in medial soft tissue.

C, MR image (TR/TE, 2850/33) obtained 2 years after subchondroplasty shows that hyperintense rim around calcium phosphate (*arrow*) has resolved.

On MRI, the injected calcium phosphate appears as a focal hypointense area or region of low signal intensity at the previous site of bone marrow edema (Fig. 5). During the first 6 months after subchondroplasty, the injected calcium phosphate may show a surrounding fine rim of high signal intensity on fluid-sensitive images (Fig. 5). If calcium phosphate leaks into the soft tissue, hypointense deposits can be seen on imaging (Fig. 5).
